QUALITY CONTROL OF PV PLANTS WITH ON-SITE MOBILE PV MODULES TEST LABORATORY

Satish Pandey (Author), Basant Jain, Sandeep Jadhav and Preetha Pillai Mahindra Susten Pvt. Ltd, Mumbai, India

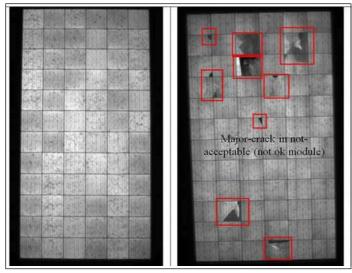
Figure 5: Sample EL image of one of the modules without &with cell cracks

Figure 5: represents the Electroluminescence (EL) image of PV modules. Figure 5.a) represent EL image of ok PV module and Figure 5.b) represent modules with cell crack. EL Test is necessary to identify faulty modules with cell cracks. The EL test was conducted to analyse the effect of installation onno of module cracks from pre-installation to post installation period. It was observed that after installation no of critical cracks increased by 0.1% (0.05% to 0.15%) which resulted into power generation loss between 2%-5%. Simultaneously, the

Figure-5.a) Sample EL image of Figure-5.b)Sample EL image of OK module not ok module

no of noncritical cracks increased by 0.2% (0.15% to 0.35%) which hampers the power generation between 0-2%. The portfolio considered for this study was 2GW.

- Thermography inspection results shows that there are 0.06% modules are defected per plant per year
- The EL tests shows that no of micro cracks increases (%) from pre installation to post installation which brings down the power generation of the respective string.
- ♦ In Flash test results it shows the Pmax degradation of healthy modules reflects 0.6% per year while the majority population (60%) of modules shows 2.6 times degradation than healthy modules.
- Recommended Periodic Testing is once a year on sampling basis
- Revenue loss due to degradation in plants can be controlled with Periodic testing
- Periodic testing of PV modules will enable to take appropriate measures which will enhance the productivity of the plant. Hence, revenue will boost
